Greenbelt Project 983

Achieve a 50% Reduction In Forklift Truck Related Incidents (Damage to Plates)

Roger Rustom MIIRSM

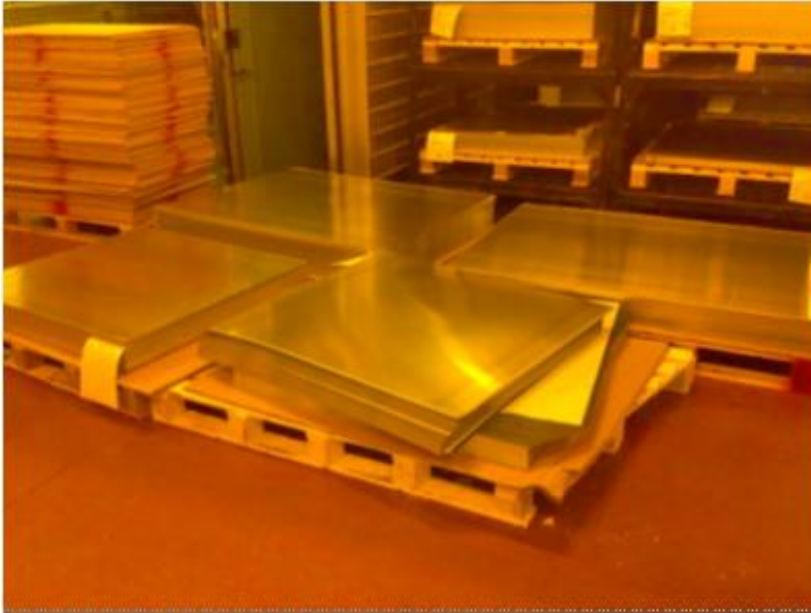
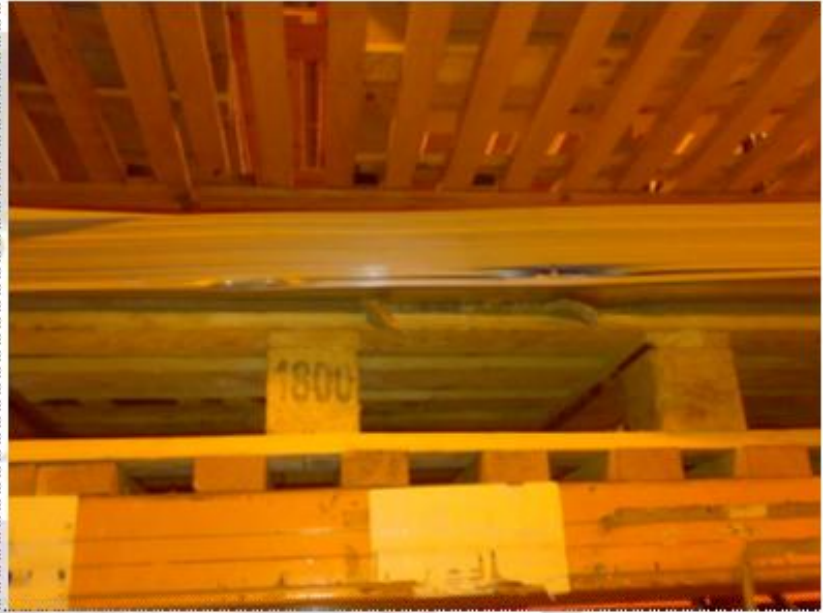
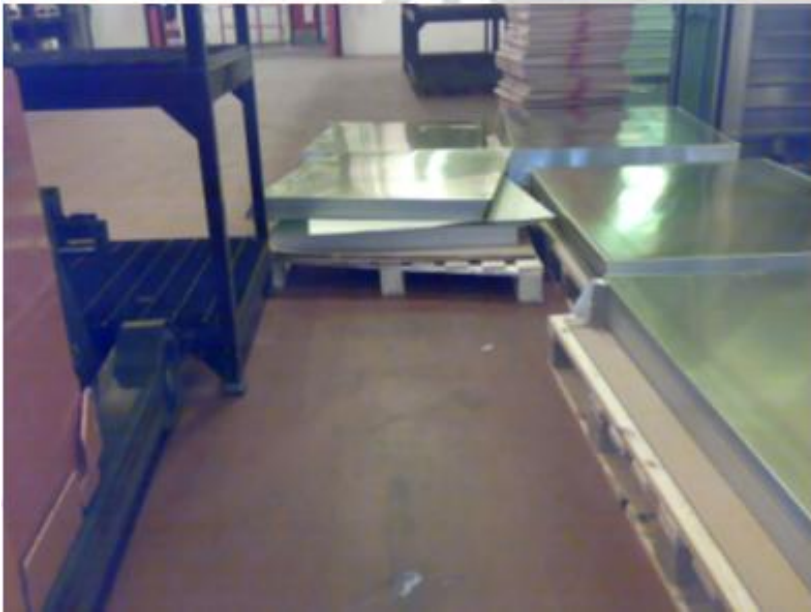
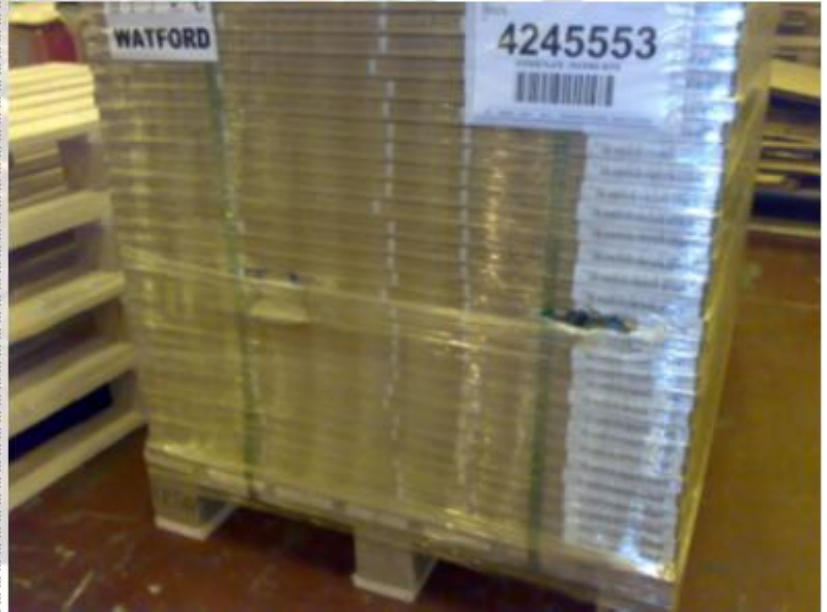
Examples of damage caused by Forklift Trucks

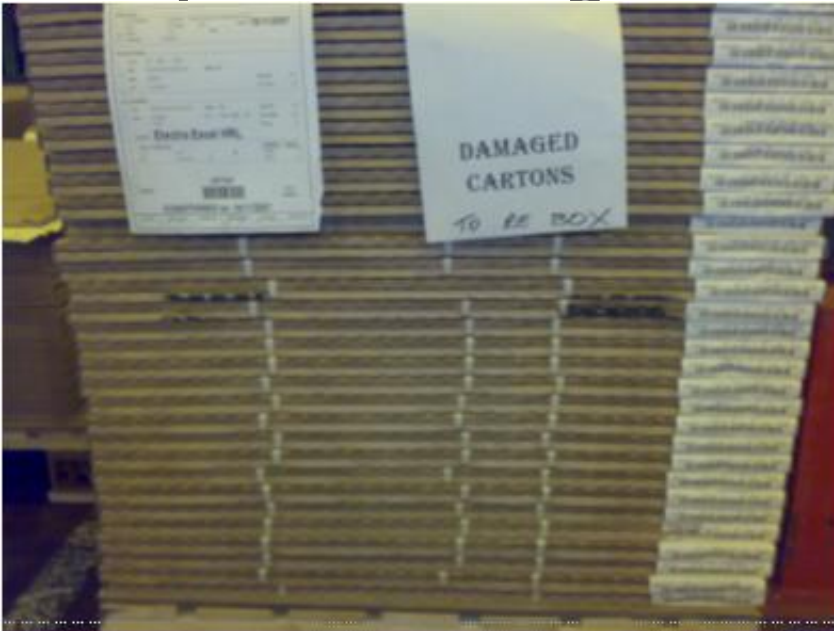
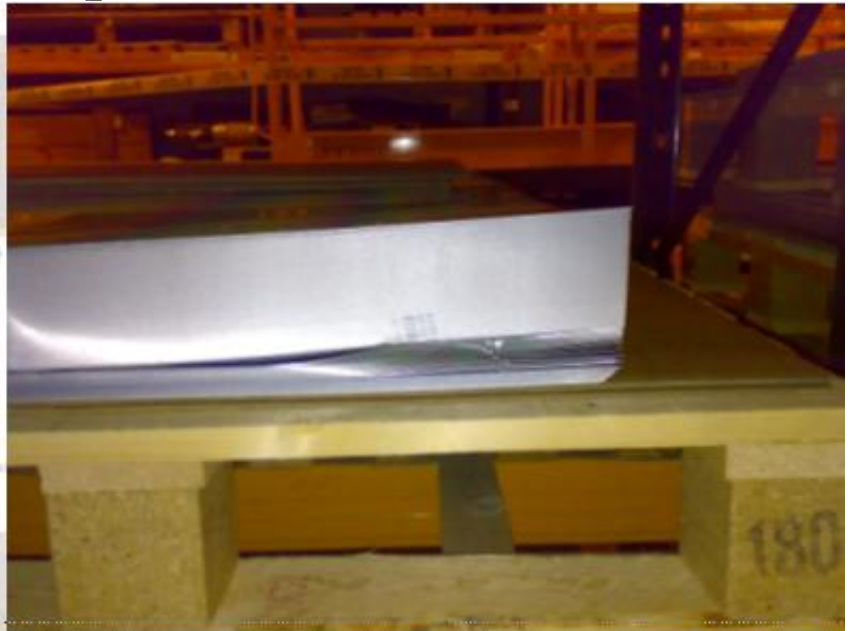
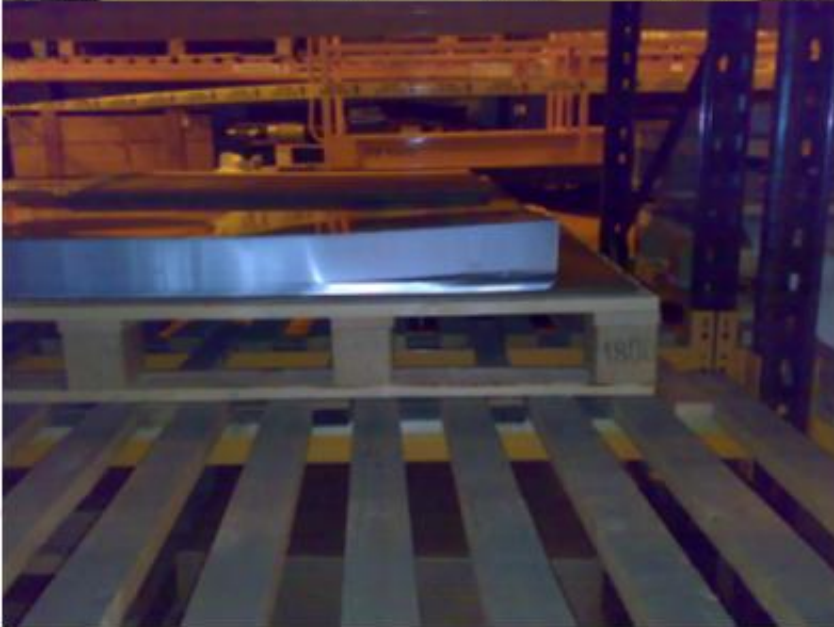
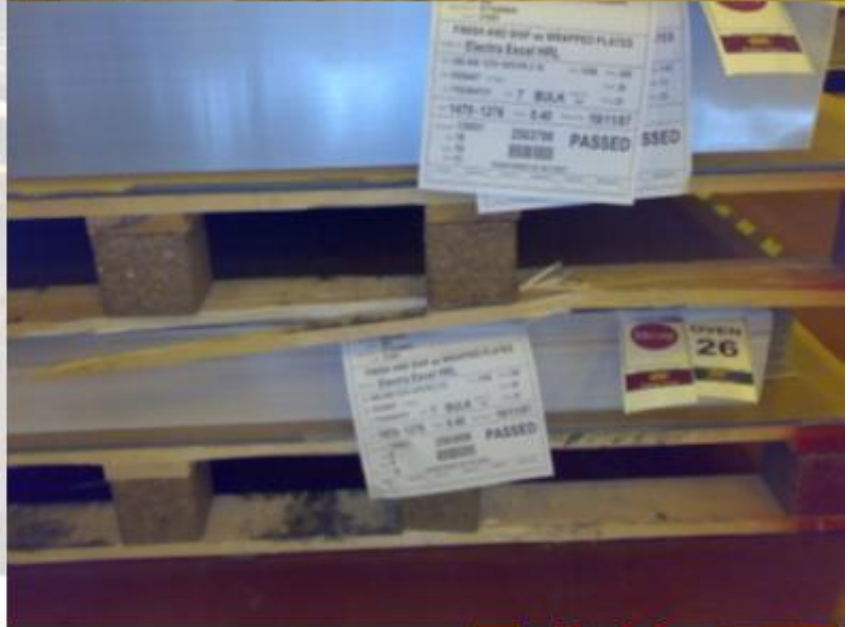
Examples of damage caused by Forklift Trucks

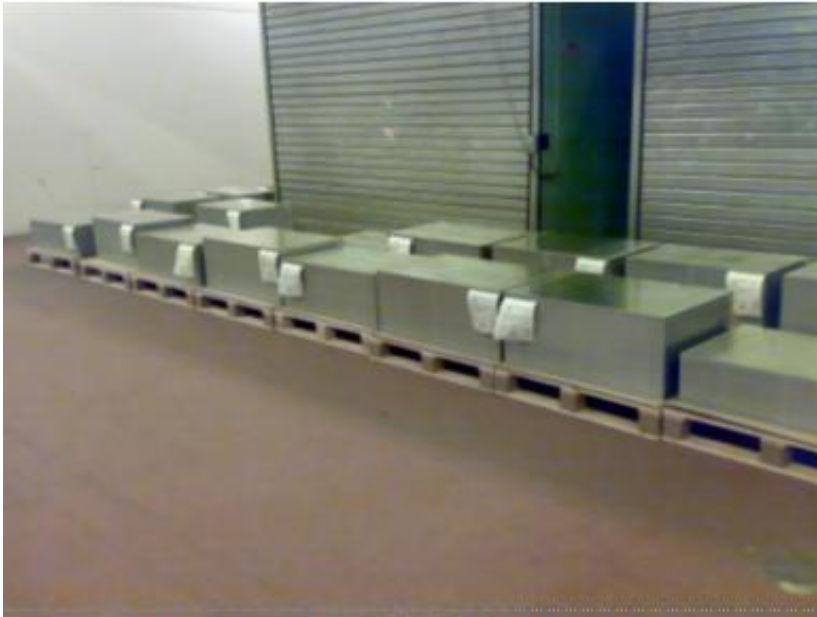
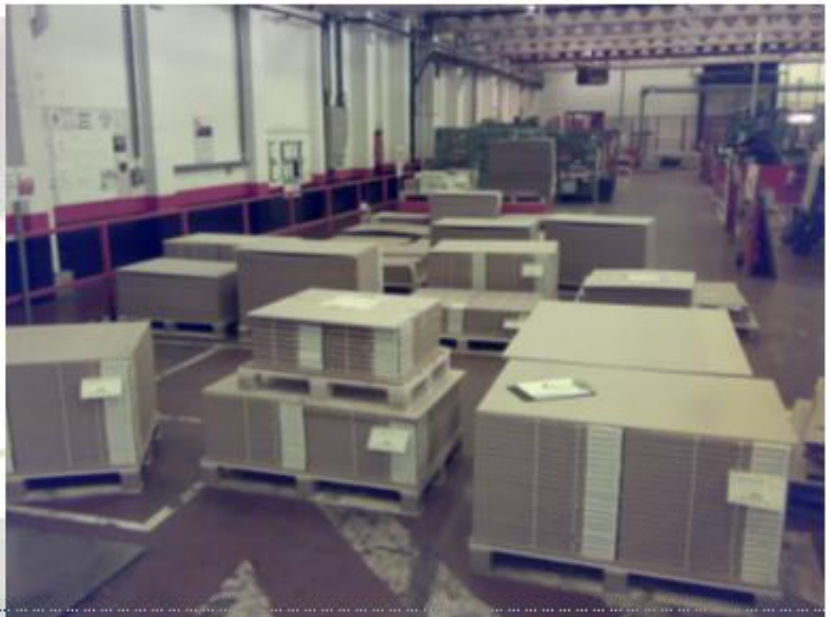
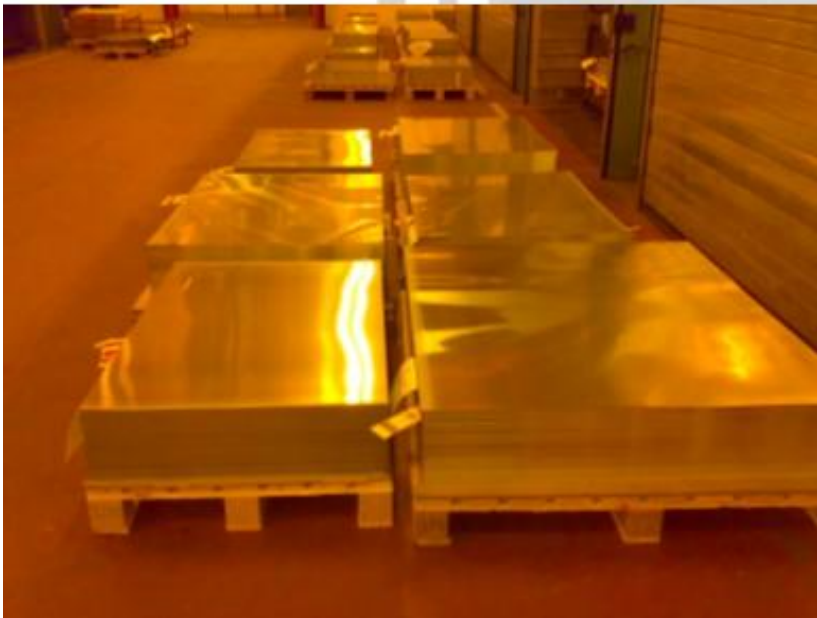
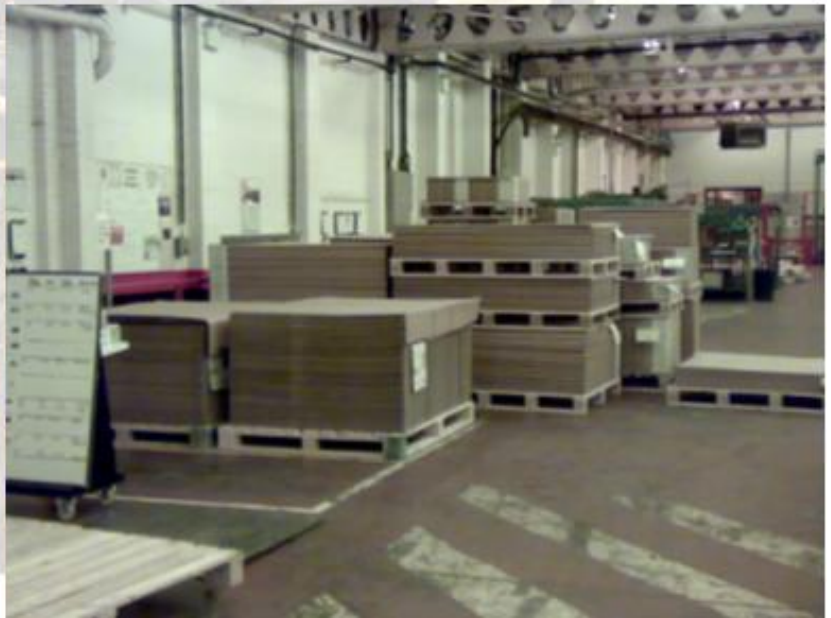
Opportunities for Forklift Truck damage to occur
